**Type B Accident Investigation Report
of the April 23, 1997, Helicopter Accident
at Raton Pass**

May 1997

**Western Area Power Administration
U.S. Department of Energy**

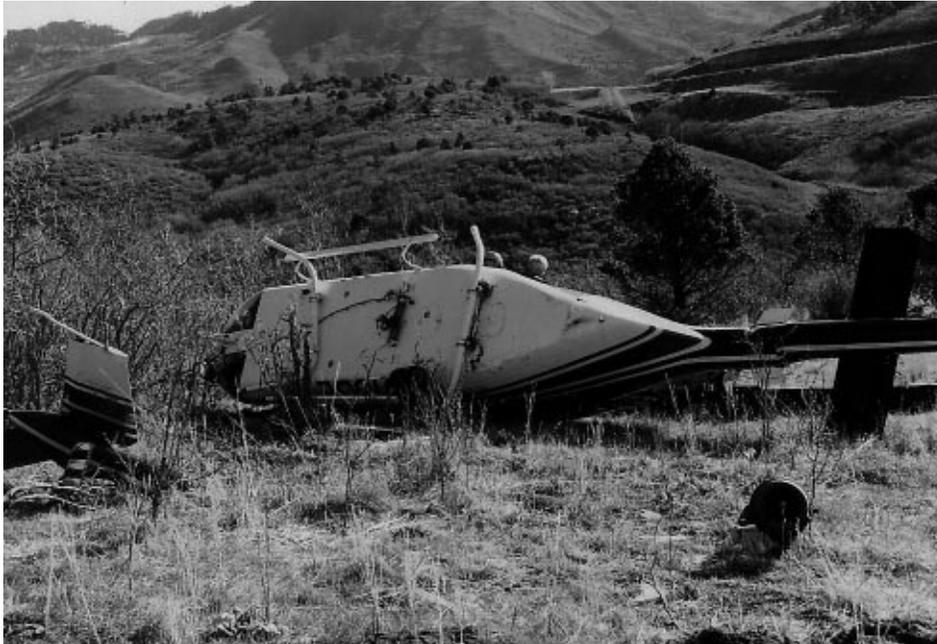
Exhibit 2.1

Accident site. Note aft portion of the tail boom, with tail rotor in foreground.

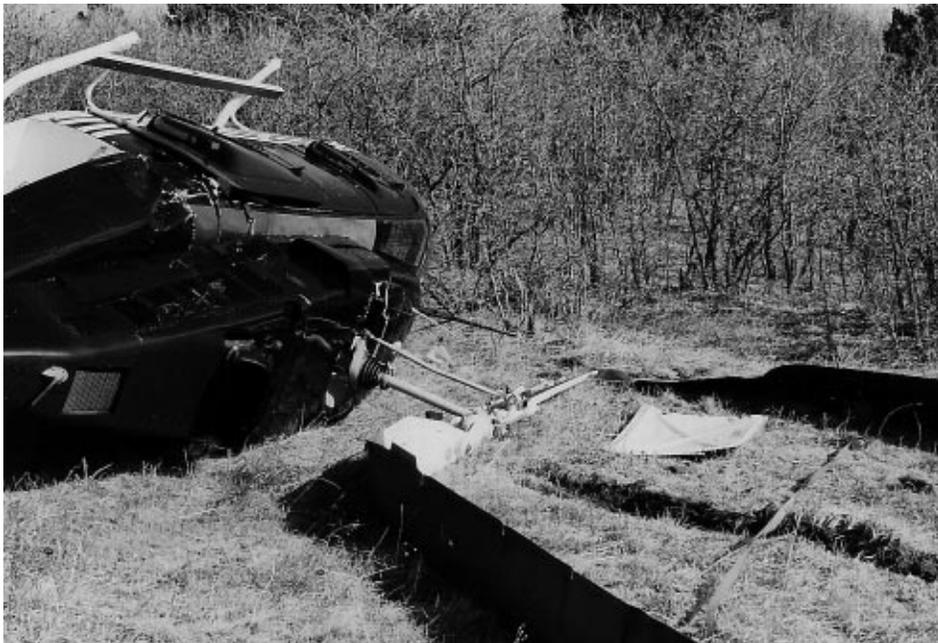
Exhibit 2.2

Ground scar from main rotor blade impact. Depth (8 inches) indicates engine was running at the time of impact.

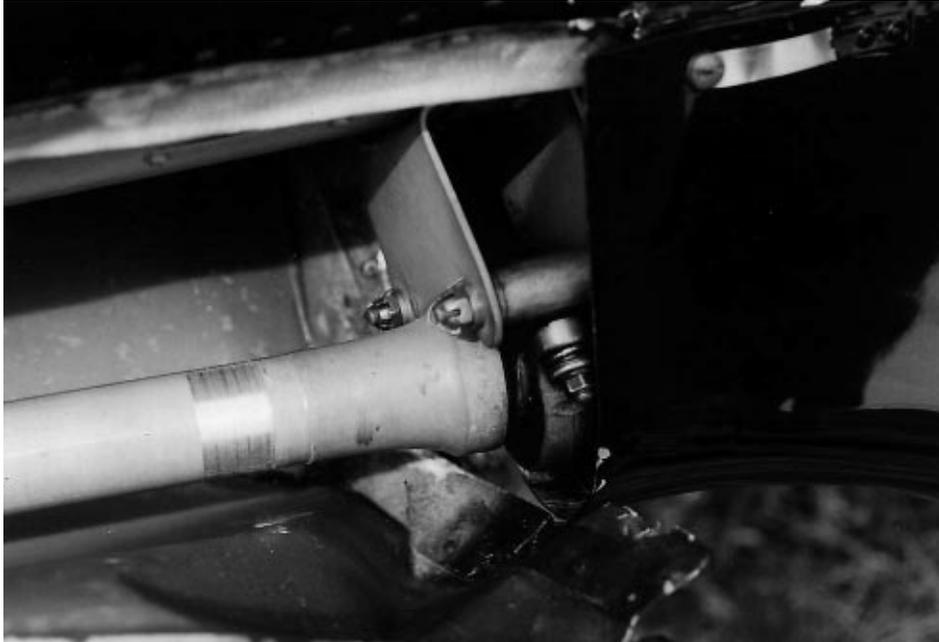
Exhibit 2.3
Scored tail rotor drive shaft. Drive shaft
was powered during impact.

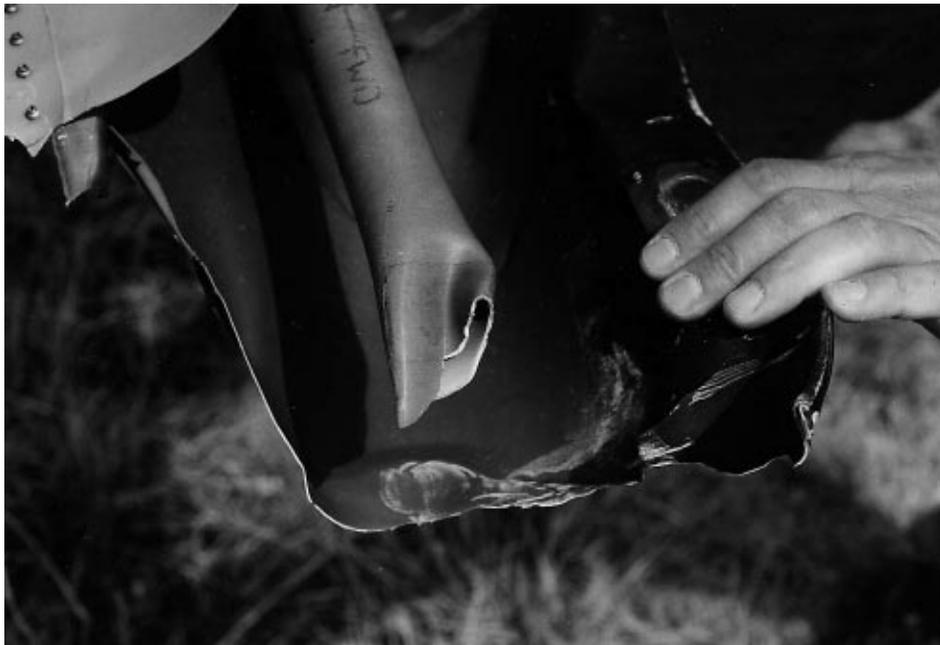
Exhibit 2.4
Tail rotor drive shaft. Twisting indicates
drive shaft was powered at time of impact.
